# Service Bulletin

**BKSB-1106**  
**Issue Date: 10/15/2026**

**Issue:** Firmware 5.15.2 has been released which addresses multiple user reported issues, including a fix to a critical issue in which users may see a false “Keyloading” display on the radios, causing voice announcements to replay when it disappears. It is highly recommended that all BKR series radio users update to 5.15.2 for the best user experience.

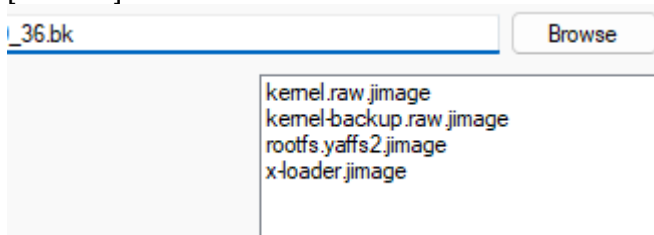
2. Execute the Lightning Firmware Load application.
3. Select the [Browse] button and navigate to the directory where the Firmware File (.bk extension) is located.
4. Select the “.bk” file. Four files should be shown in the source file box just below the [Browse] button:
