Windows 10 Driver Installation , BKR Service radios FW

PUBLIC Rev. 07/26

Issue: USB driver has been updated to CDC-NCM to ensure forward compatibility with more devices and more robust feature set.

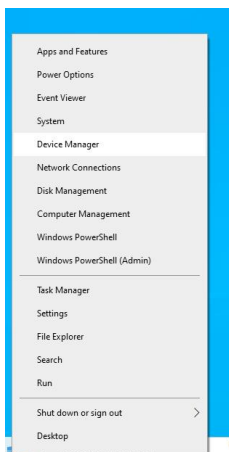
1. Right click on the Start Menu icon, select “Device manager” from the list:

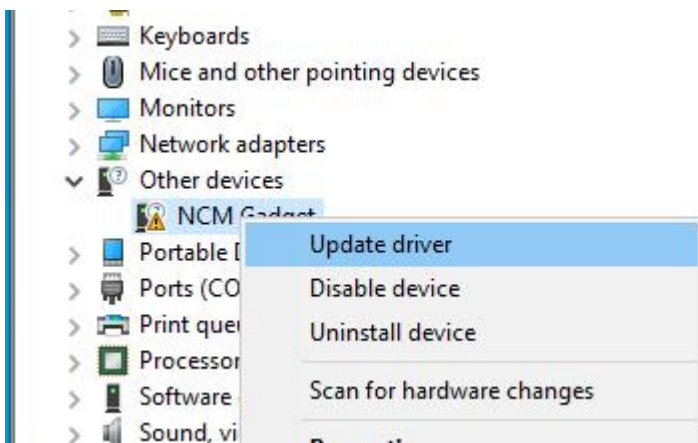
2. Radio will appear as “NCM Gadget” under “Other devices” right click and select “Update driver”

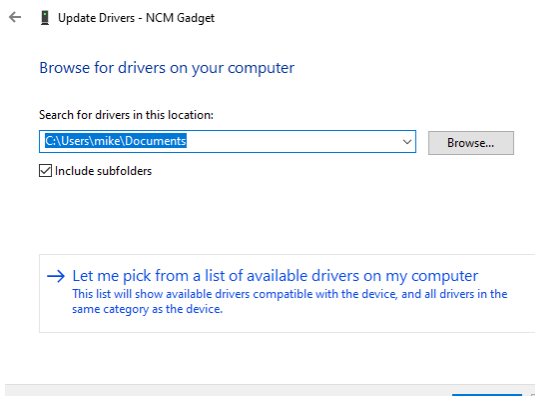
3. In the window that appears, select “Let me pick from a list of...”

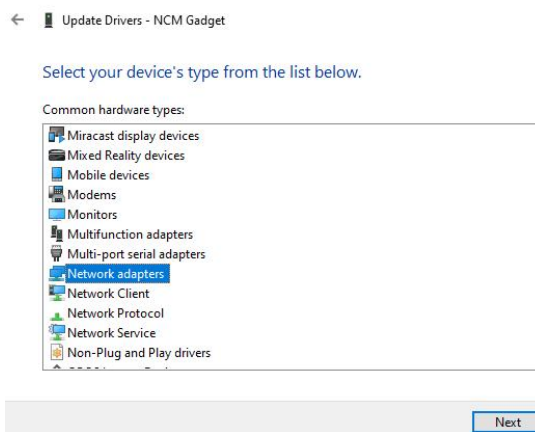
4. Select “Network Adapters” for your device’s type.

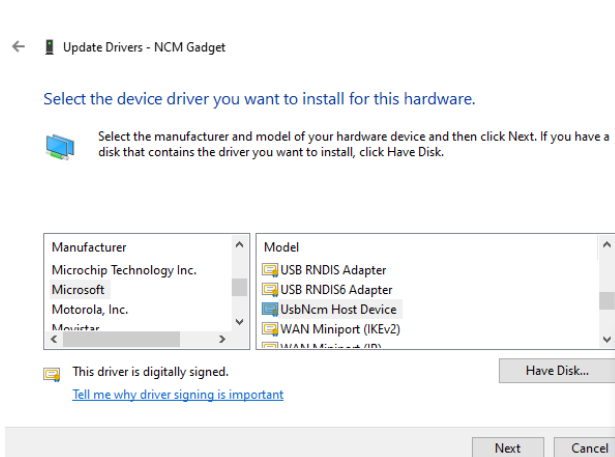
5. For “Manufacturer” select “Microsoft” and “Model” select “UsbNcm Host Device” and click “next”

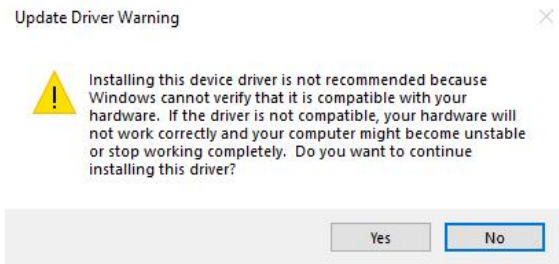
6. Windows will warn that it cannot verify the device type. We are sure which device is connected, click “yes” to continue.
